NEW MEXICO
ENVIRONMENT DEPARTMENT

Memorandum

Subject: Pre-CERCLIS Screening Assessment of Faith Mine, McKinley
County, New Mexico: Further action under CERCLA
recommended

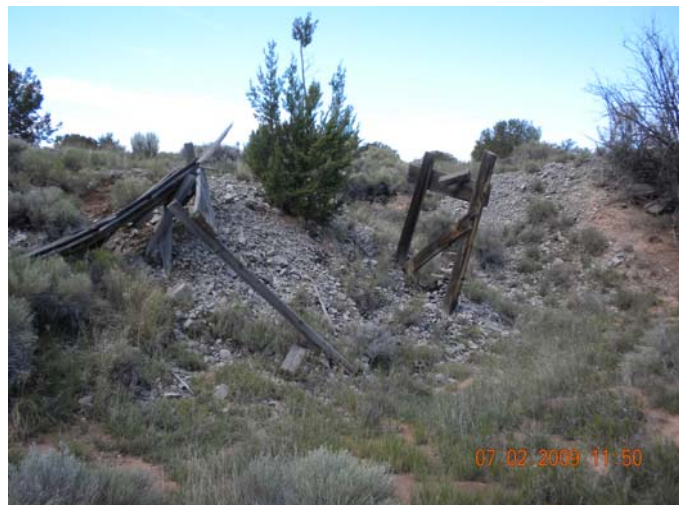
P1: Faith Mine Possible load-out structure remains along arroyo

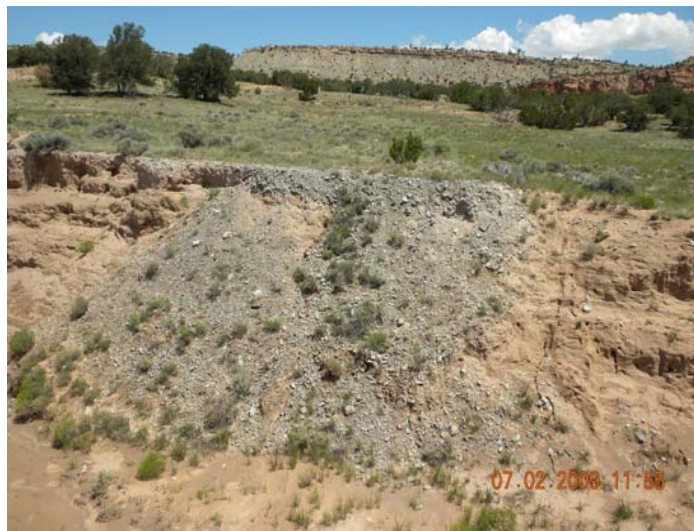
Site summary: Observations made during NMED's Site reconnaissance are shown on the accompanying figures. The waste piles examined had elevated radioactivity (highest

reading=578 counts per second (cps); background=15 cps). Contamination might be dispersed by precipitative erosion and wind, and may enter the bedrock ground water system through alluvial interconnections.

P2: Faith Mine view to northeast; waste cut by arroyo

1. Remove waste with elevated radioactivity.
